Art Conservation *and family histories*

ARTC Spotlight—January 2025

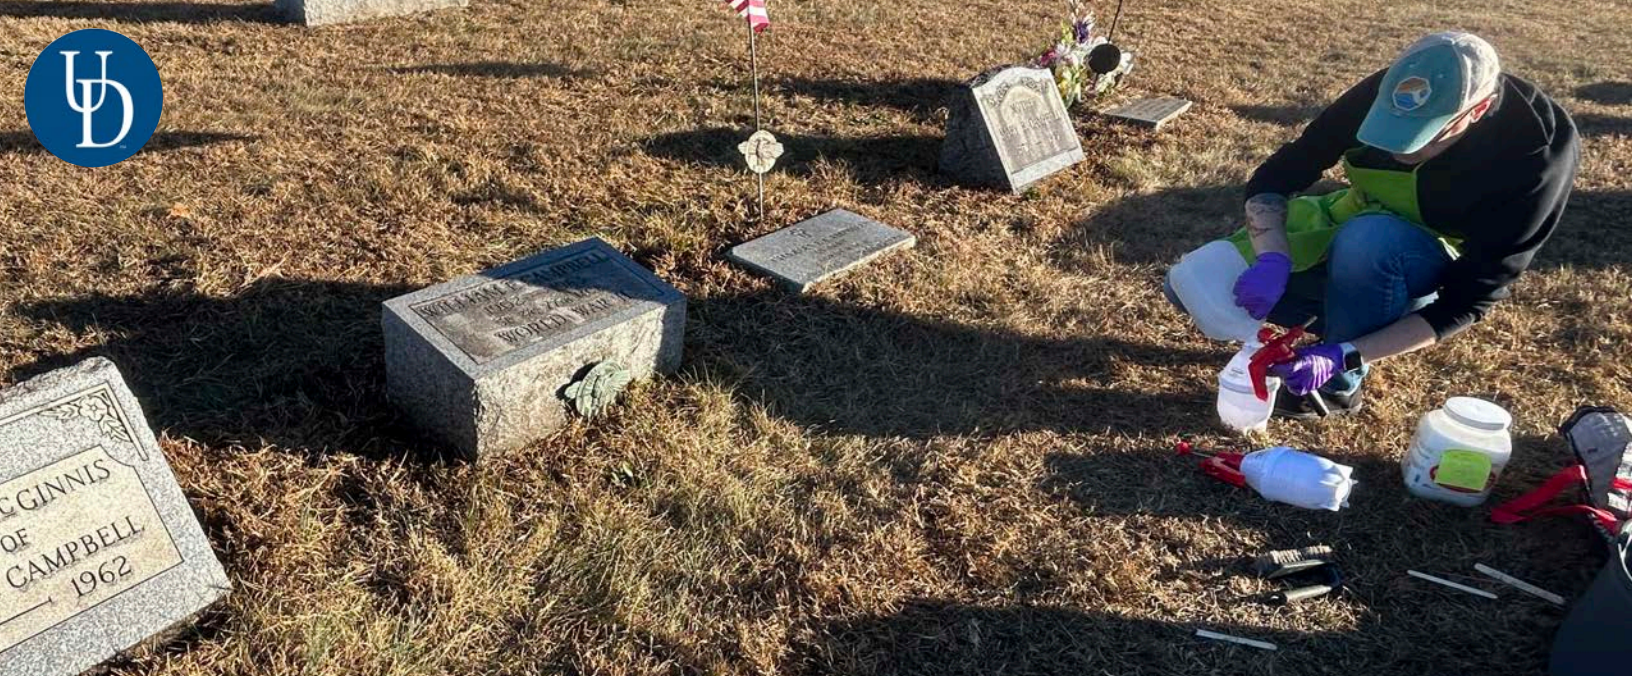
Top: ARTC Affiliated Assistant Professor William Donnelly preparing supplies next to four of his family’s gravestones. Above: Winterthur/University of Delaware Program in Art Conservation Fellow Binh-An Nguyen spraying water to wet a gravestone surface. Right: Binh-An scrubbing a stone to remove biogrowth, and the gravestone after cleaning. (Images: Binh-An Nguyen and William Donnelly)

She looked to monument conservators at Arlington National Cemetery, and two recent graduates of the Winterthur program who’d worked with indigenous gravestones, to learn how they cleaned and preserved stone. “It was about wetting the surface, using a 50:50 solution of water and a biocide that kills off biogrowth,” she explains. She and William tried it on four of his family’s gravestones, and it worked, revealing a decorative motif and uncovering the obscured names. She also made recommendations to mitigate future biogrowth, involving annual cleaning. “I advised, ‘don’t do it more than once a year, because it can add to instability or wearing them away,’” she notes.

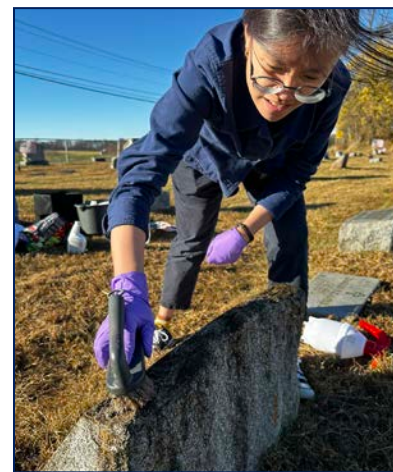
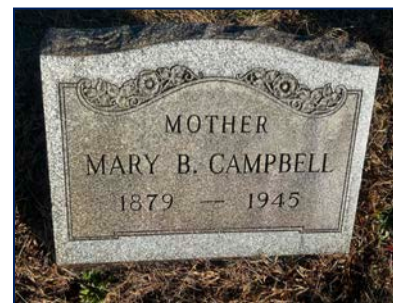
She further discovered that William’s family gravestones were made up of two different types of stone: a primary smooth stone that remained relatively free of biogrowth, and an inset on the face, that was made of a rougher stone. “Biogrowth likes the rougher areas because they hold moisture better,” Binh-An says. “It was a perfect environment for them to spawn.”
